EXTERIOR OF TRAILER

INTERIOR OF TRAILER

FOUNDERS HALL DINING AREA

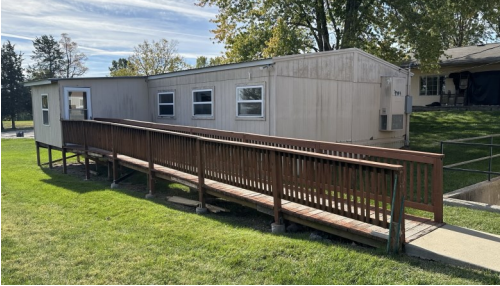
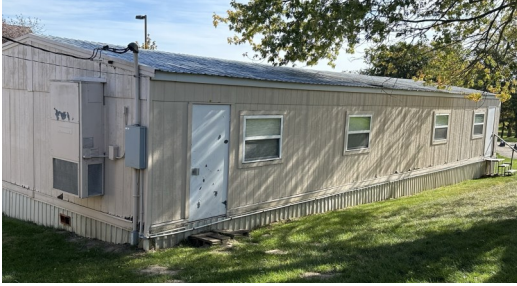
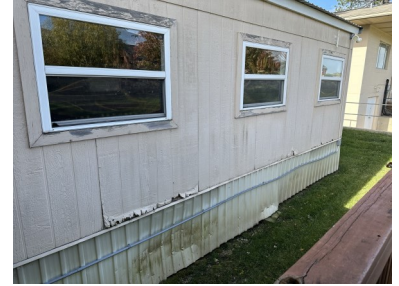
- The wooden ramps needs to be replaced
- The 27 year old HVAC is unreliable
- The exterior is falling apart
- It is not well insulated
- It has exceeded its life span and is an eyesore

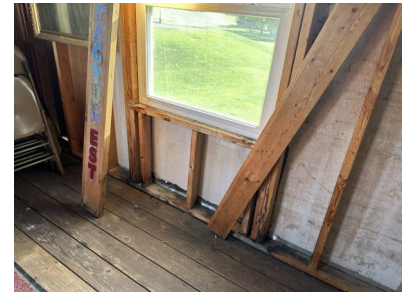
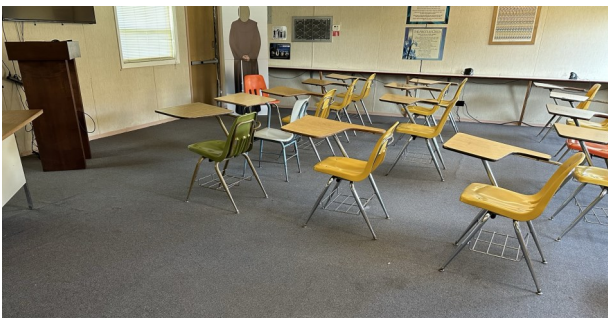
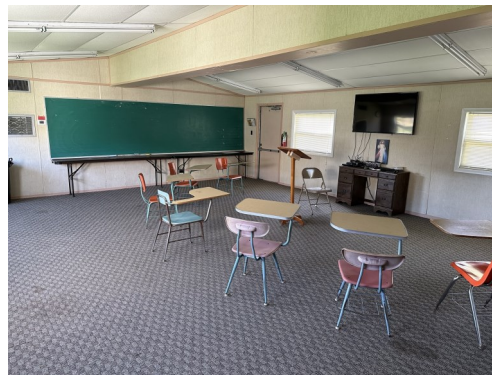
- Extensive deterioration
- There is no intercom for emergencies
- No bathroom facilities
- Exterior doors not fitting well—note the weather stripping
- The electrical system is outdated

The trailer was purchased in 1996 and was to be “temporary.” It is showing a lot of wear and tear, and isn’t up to code due to the fact that there are no bathroom facilities in this unit.

The lack of an intercom system is significant for the safety of the students and teachers. We currently use personal cell phones to communicate with all classes.

It is generally an old, inefficient and outdated building, with leaky doors, and no resale value.

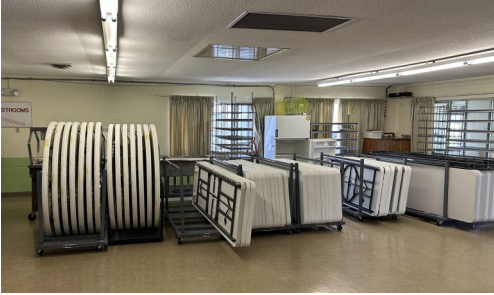
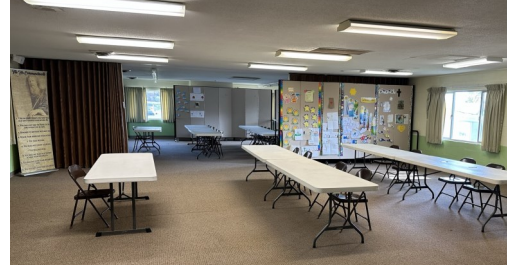
- There is a tremendous lack of storage, so all the tables and chairs are in full view
- The restrooms are in the lower level, so not handicapped accessible
- Two wooden doors need to be replaced
- There are room dividers for PSR classes, of which there are three every Sunday
- Hall has to be set up each week for classes, having to work around the various activities

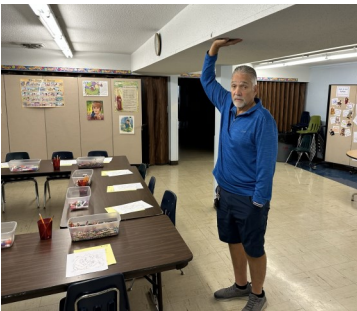
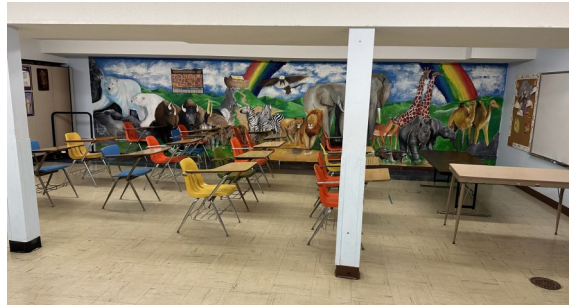
FOUNDERS HALL LOWER LEVEL

- First of all, it's a basement, with low ceilings covering the ductwork
- The downstairs restroom facilities provide little privacy
- The space is very inadequate for separate classrooms, of which there are two
- Technology is very outdated

In general, the electrical service equipment in Founders Hall is old and outdated. The numbers of circuit protection devices are at the limit allowing little or no room for growth and considerable difficulty in maintenance or repair.

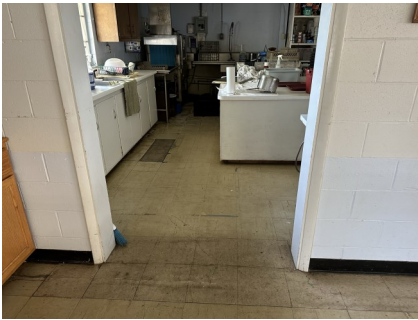
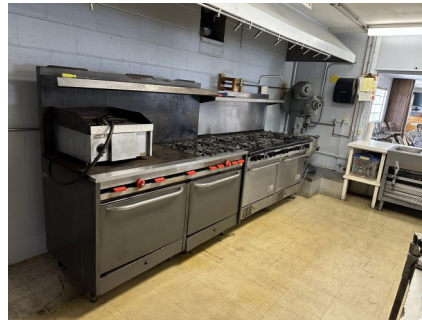
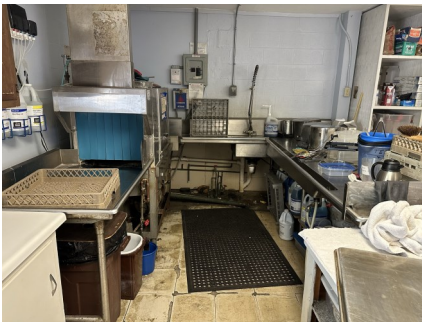
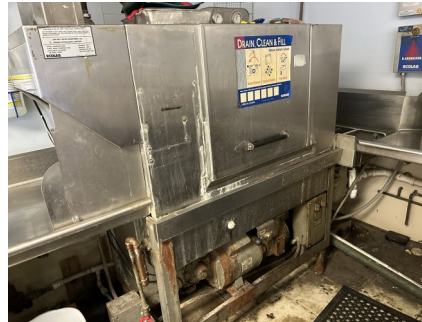
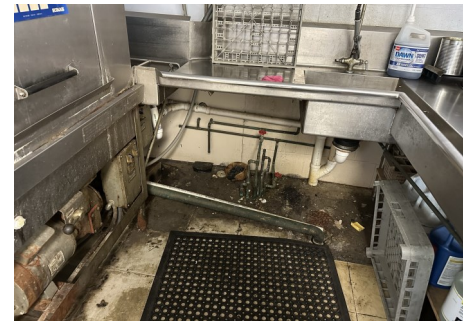
FOUNDERS HALL KITCHEN

- Floor tiles are in poor condition and cracking
- The cooking area is very crowded, with old equipment
- The ventilation hood over the cooking stoves has recently been replaced for > \$7,700
- The serving area is small, compact, with cooking pots and pans stored in every available space
- There is only room for one or two in the dishwashing area
- A major kitchen updating should be in the plans

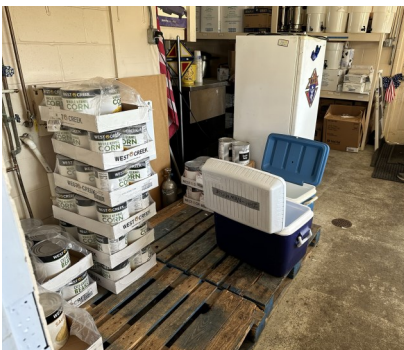
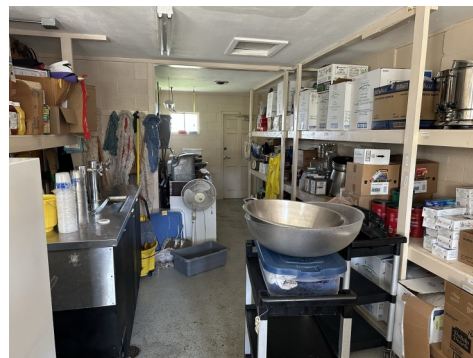
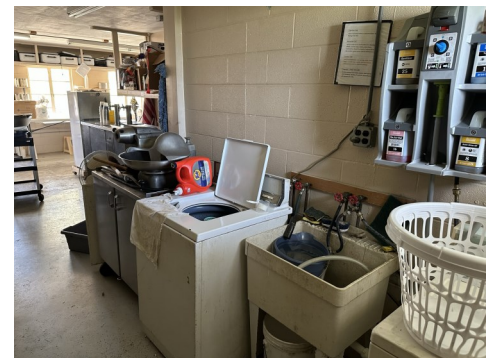
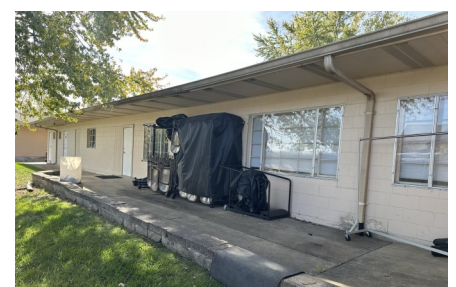
FOUNDERS HALL STORAGE

- Very crowded work and storage space
- Using other buildings to store food and supplies
- There is not enough room indoors for chair storage, so they are covered by a tarp and stored outside
- As is the rest of the building, the windows are drafty with little or no thermal resistance and insulation from outside temps

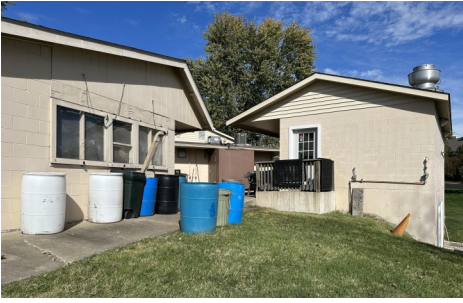
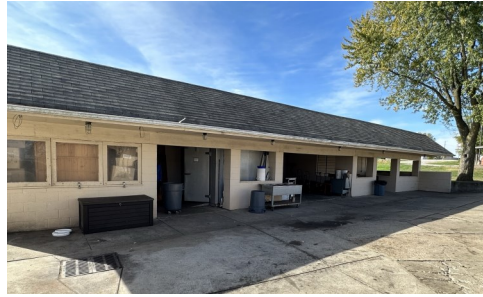
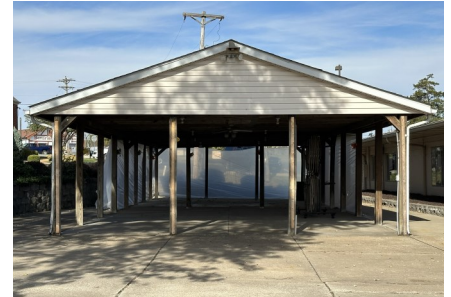
OTHER SPACES USED FOR STORAGE AND OVERFLOW

- While trying to stay out of sight, much of the equipment and supplies used in the cooking process are sitting outside
- Much of the storage is exposed to the weather
- The pavilion comes in handy for extra space to handle the overflow due to increasing growth in the area
- Buildings that were originally built for game booths and concessions are now used for storage

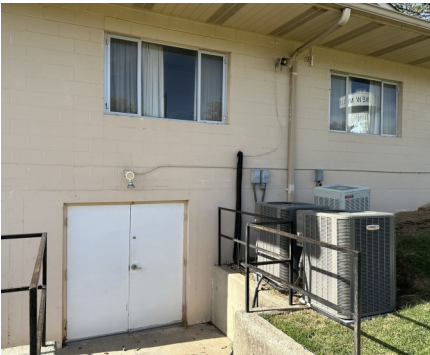
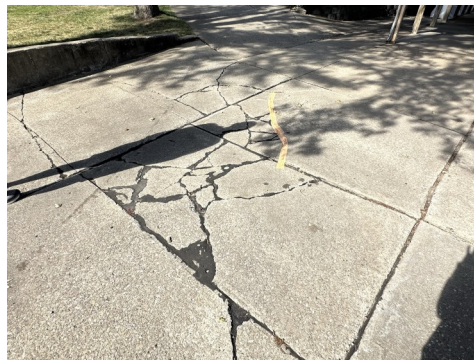
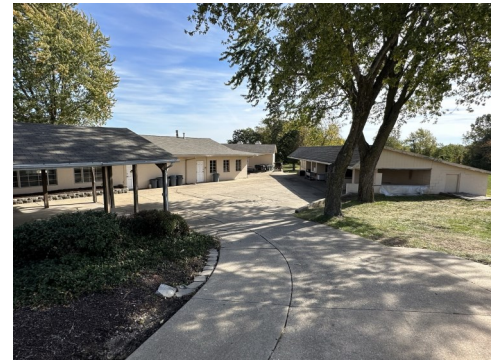
EXTERIOR CONDITIONS

- Inefficient furnace and air conditioning was recently replaced for \$12,000.
- Concrete walking paths and driveways are cracking
- We have at least 5 separate outdated and deteriorating buildings which are needed to “pull off” our major events

Out of necessity we keep up with maintenance on the buildings. A recent expense was replacement of furnace and AC units in Founder Hall. Always a difficult decision to put money into these old buildings in order to keep up with normal activities.
